PRELIMINARY PROFILES

FIRWOOD LANE

PRELIMINARY PLAT / IDP

CITY OF KIRKLAND WASHINGTON

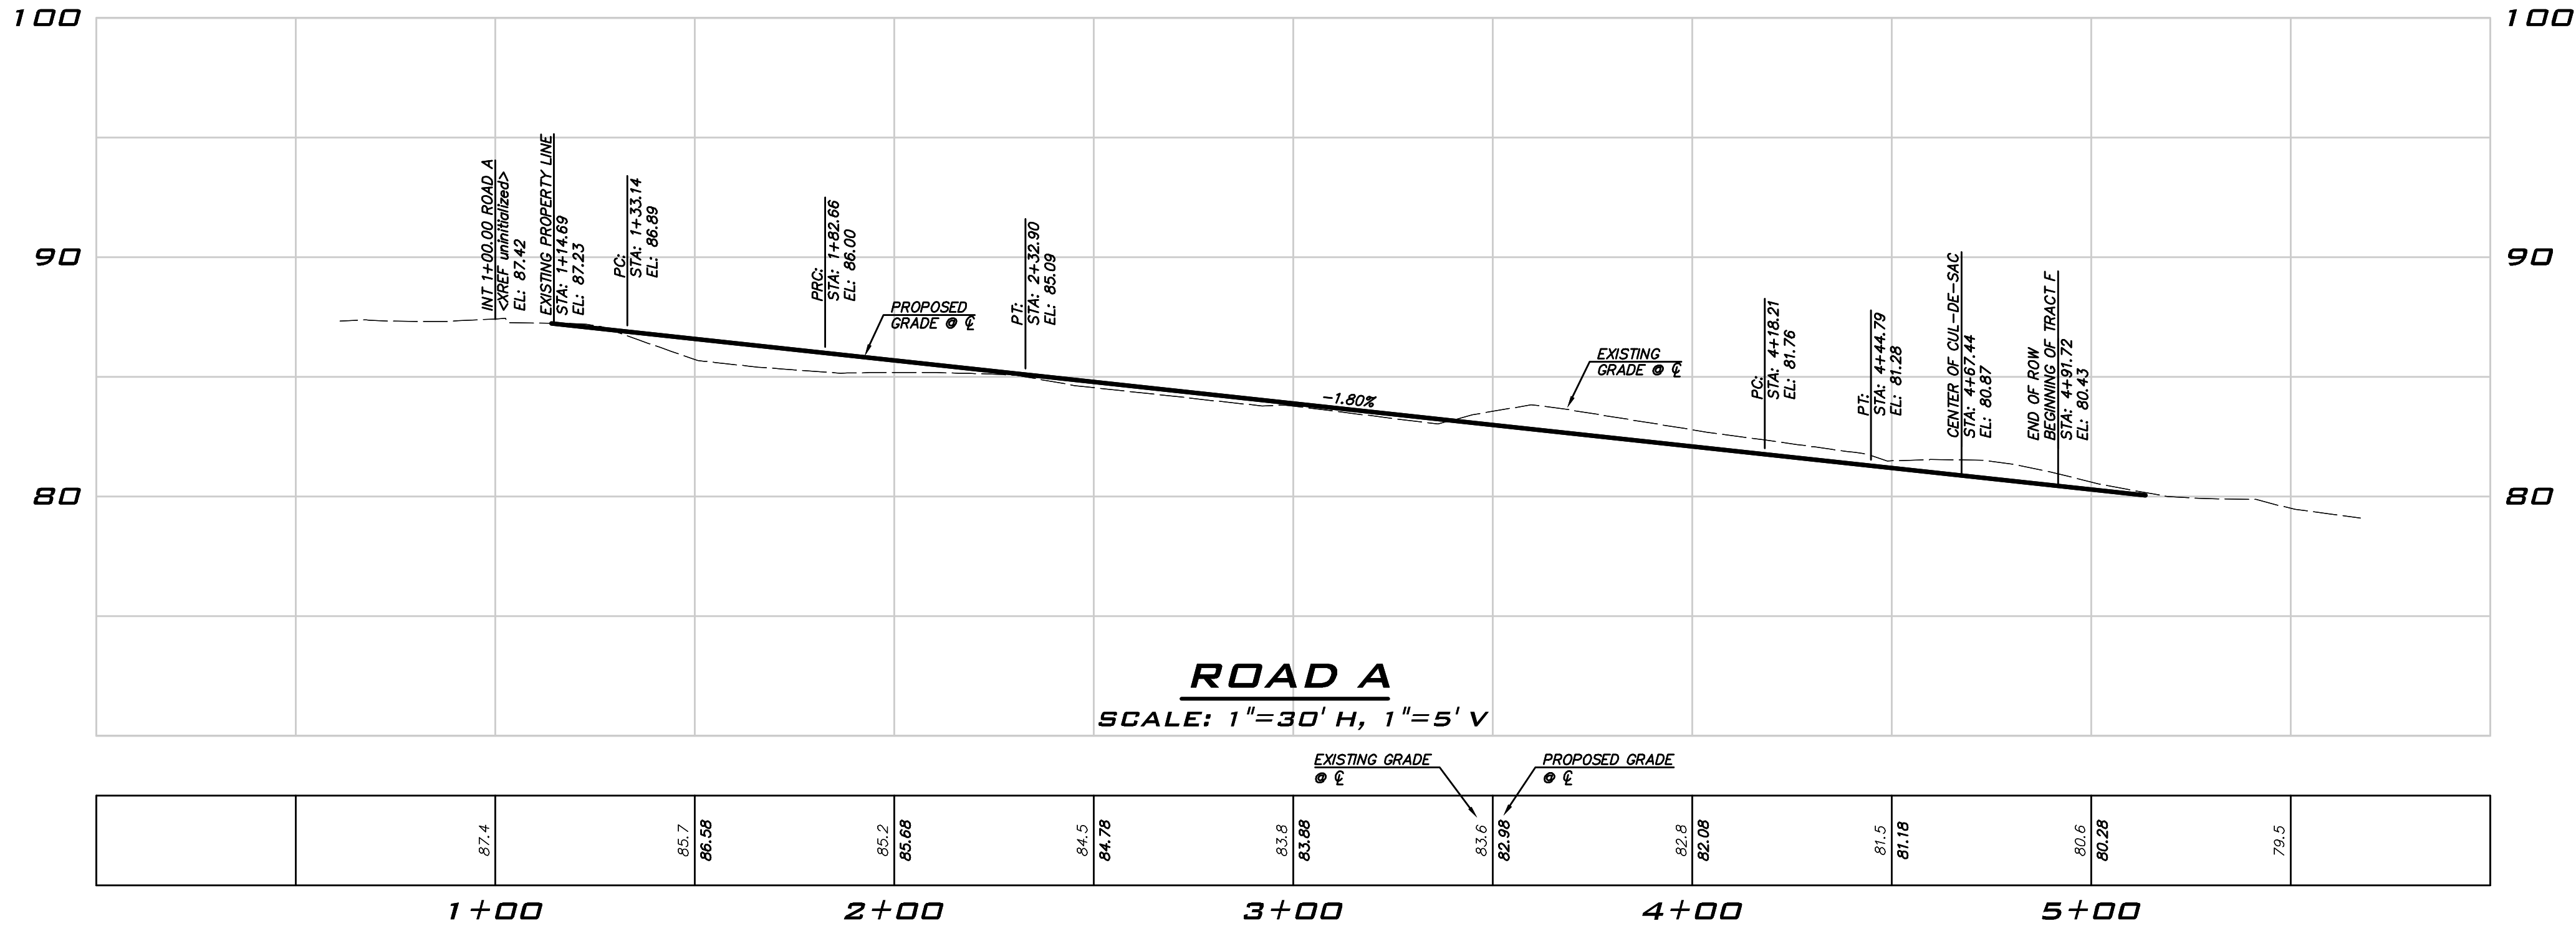
PR-01

CUT: 1,000 CY
FILL: 1,100 CY
NET 100 CY FILL

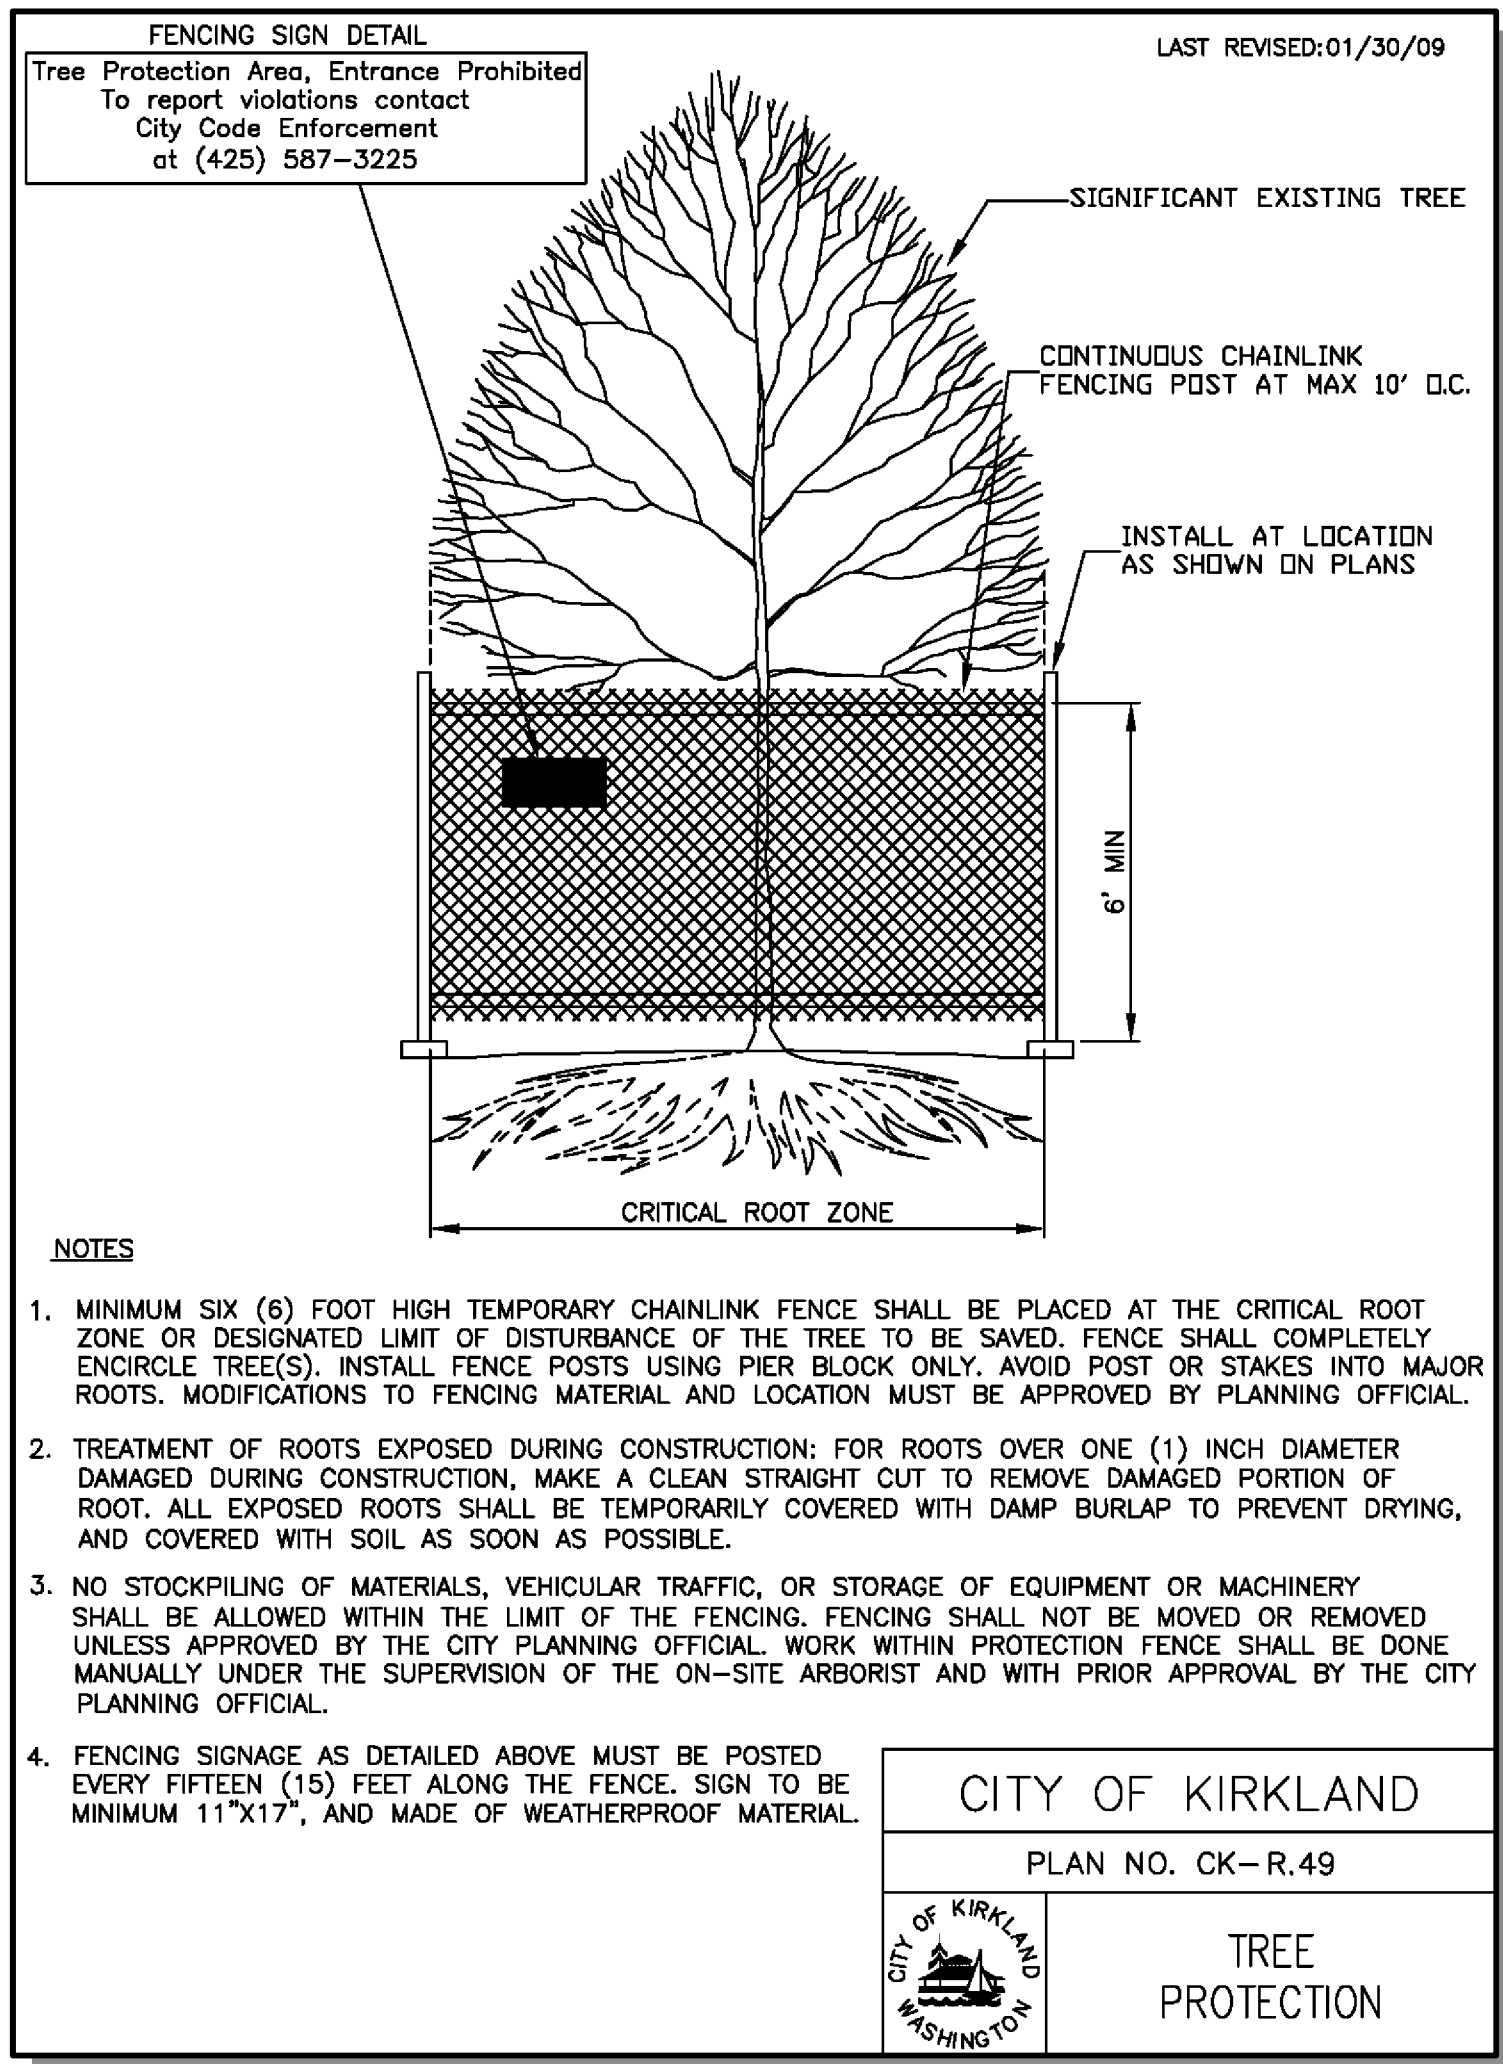
TREE PROTECTION MEASURES

3. TREE PROTECTION FENCES WILL NEED TO BE PLACED AROUND EACH TREE OR GROUP OF TREES TO BE RETAINED.
- A. TREE PROTECTION FENCES ARE TO BE PLACED ACCORDING TO CITY STANDARD PLAN NO. CK-R-49 AND AS NOTED IN THE TRENDATORY/CONDITIONS SPREADSHEET, COLUMN 6 - LIMITS OF DISTURBANCE (SEE ARBORIST REPORT DATED 6/14/12).

- TREE PROTECTION AREA, ENTRANCE PROHIBITED
TO REPORT VIOLATIONS CONTACT
CITY CODE ENFORCEMENT AT
425-587-3225**
4. THE AREA WITHIN THE TREE PROTECTION FENCING MUST BE COVERED WITH WOOD CHIPS, HOG FUEL, OR SIMILAR MATERIALS TO A DEPTH OF 8 TO 10 INCHES. THE MATERIALS SHOULD BE PLACED PRIOR TO BEGINNING CONSTRUCTION AND REMAIN UNTIL THE TREE PROTECTION FENCING IS TAKEN DOWN.
